**Subject:       Abbreviated Preliminary Assessment Checklist**  
**PRIDCO Building Nos. T-1317-0-80 & T-1317-1-89**  
**TDD No.: 0004/1605-14**  
**Contract No.: EP-S8-13-01 (Region 8 START IV)**

## ABBREVIATED PRELIMINARY ASSESSMENT CHECKLIST

**Site Name:** PRIDCO Building Nos. T-1317-0-80 & T-1317-1-89

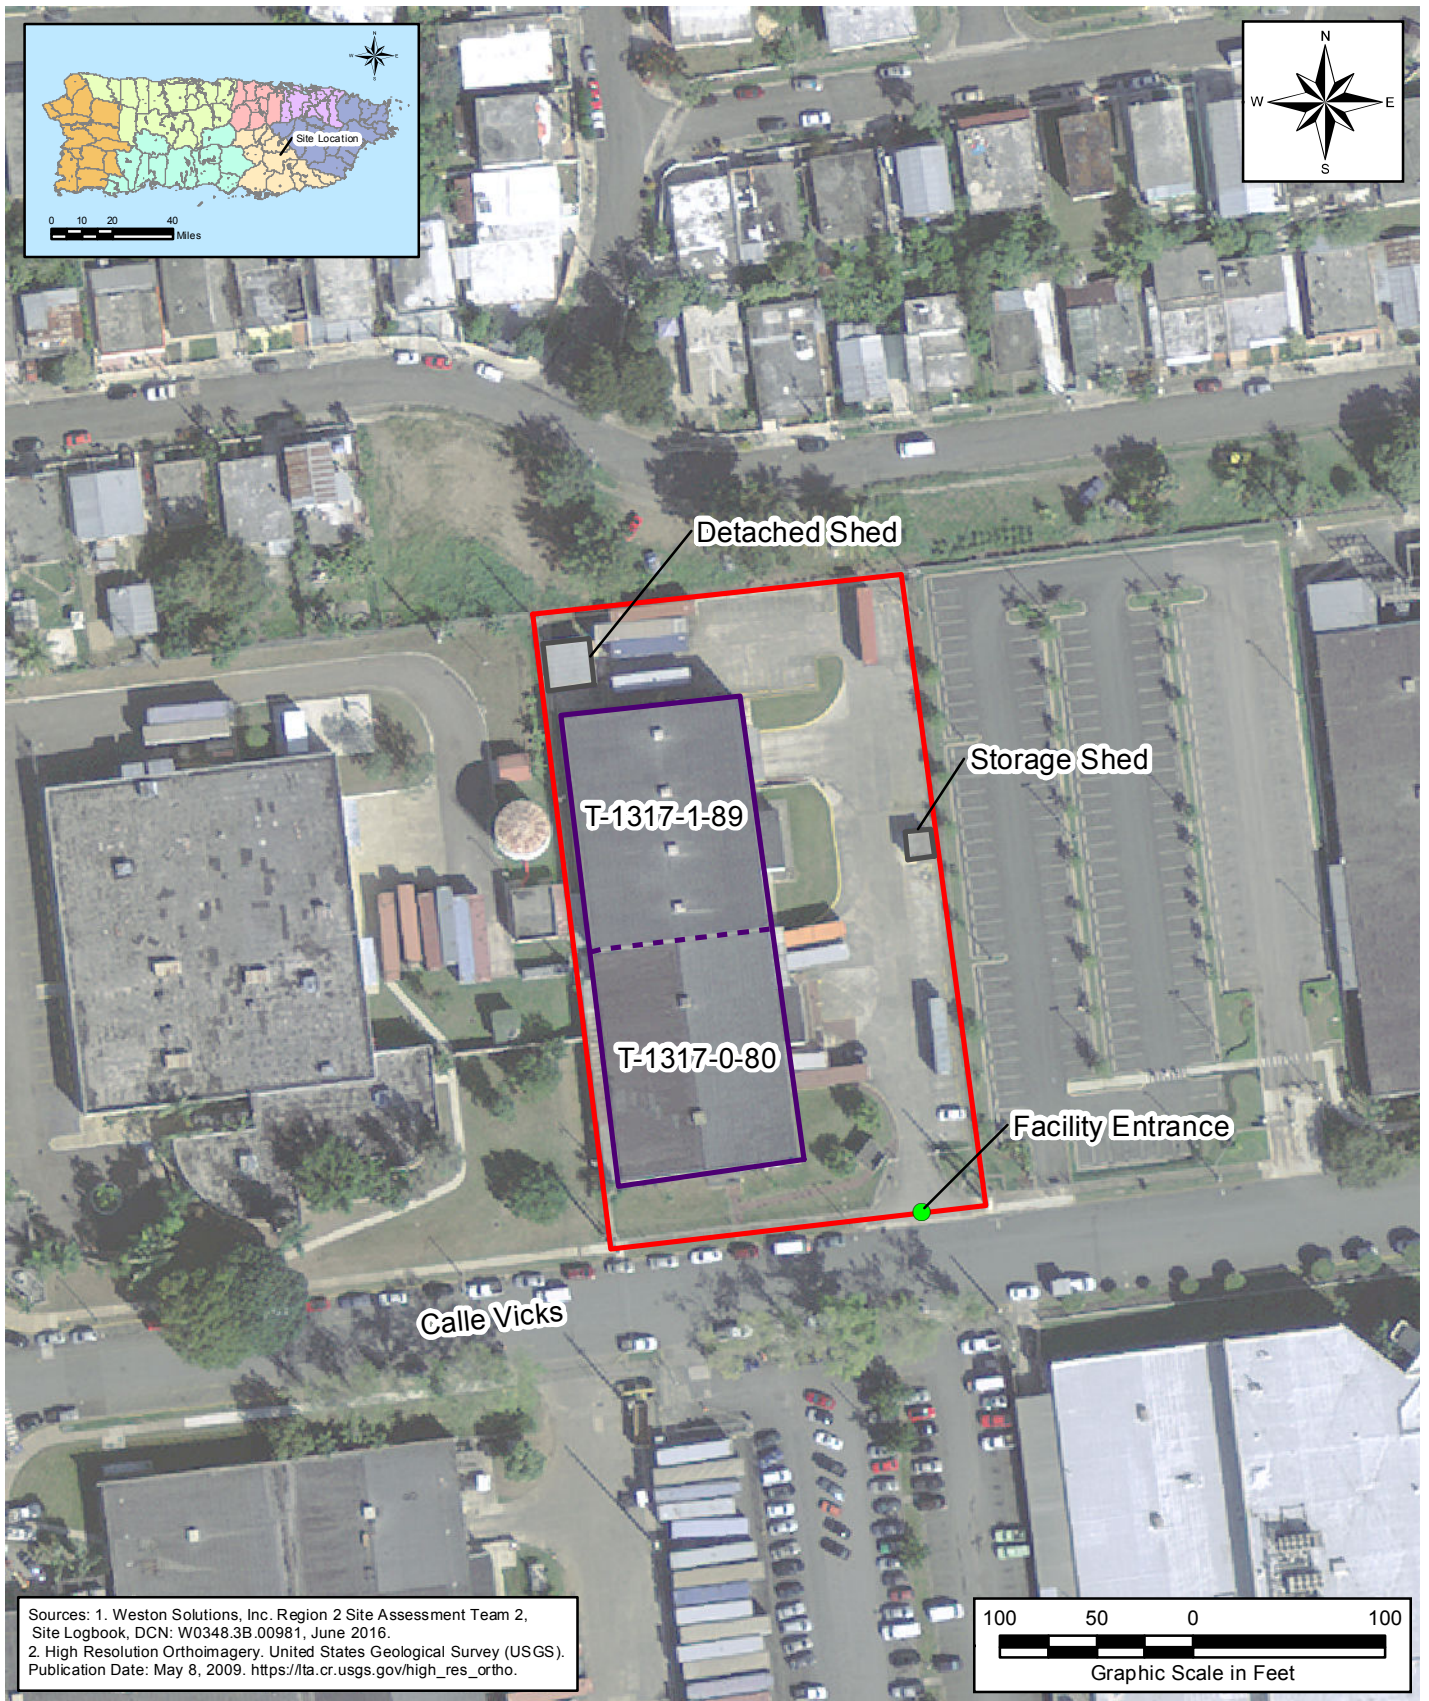
1

Site Map  
 PRIDCO Building Nos. T-1317-0-80 & T-1317-1-89  
 Cayey, Puerto Rico

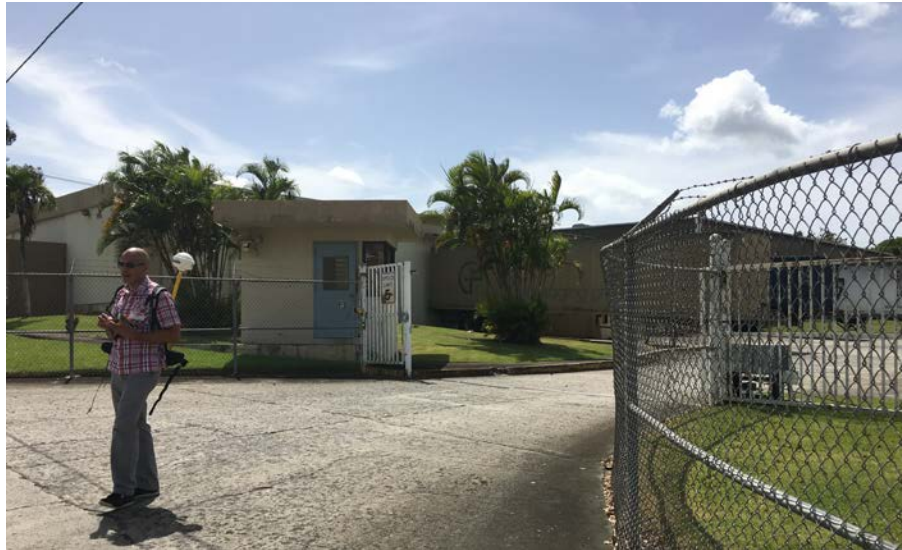
**Photograph 1** – View looking northwest at the entrance to warehouse located on the property. Exposed soil is located on the southern portion of the site.

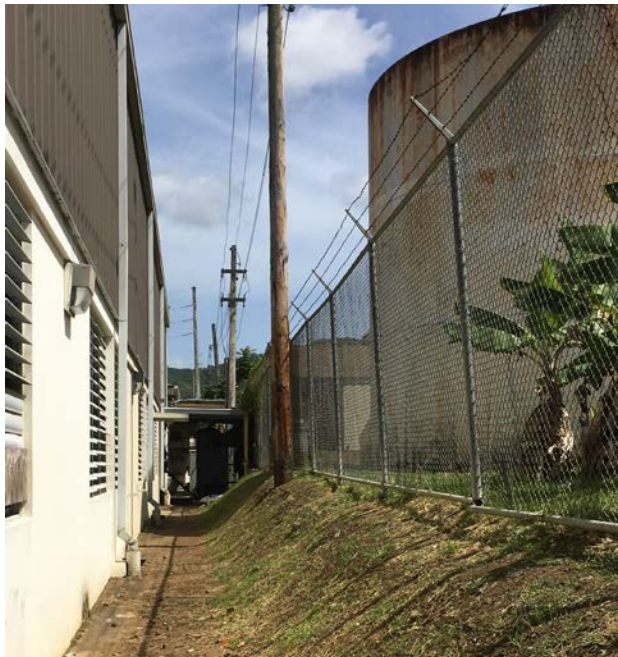
**Photograph 2** – View of the western boundary of the site with limited access. A small shed with unknown purpose is located in the northwestern portion of the property.

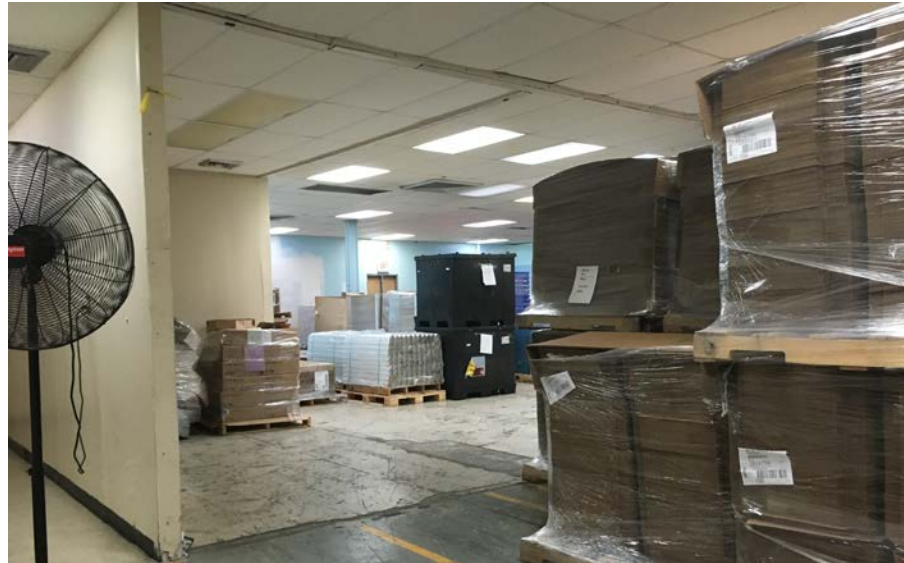
**Photograph 3** – View of shipping supplies and equipment located inside the warehouse facility on the property.

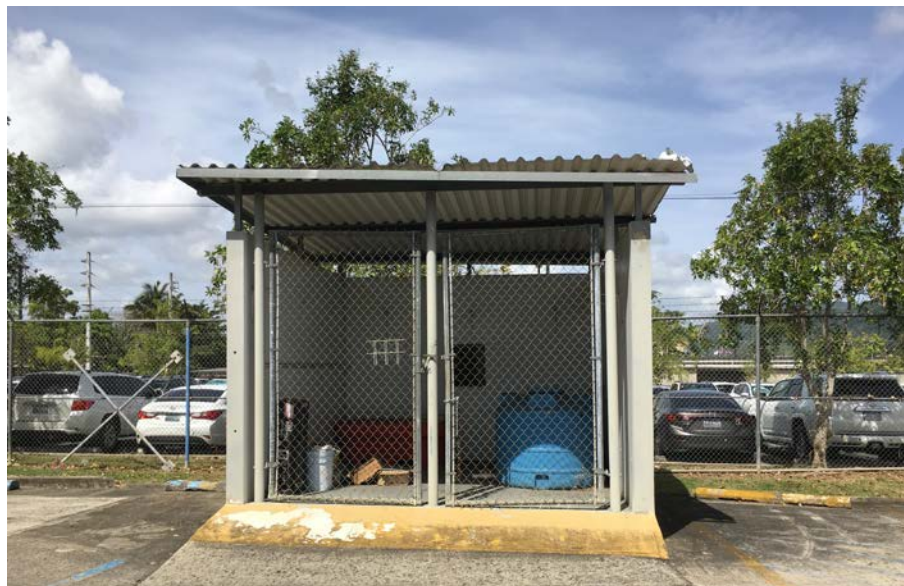
**Photograph 4** – View of unlocked storage area with equipment/materials left from previous renters. Storage area is located on the eastern portion of the property.
